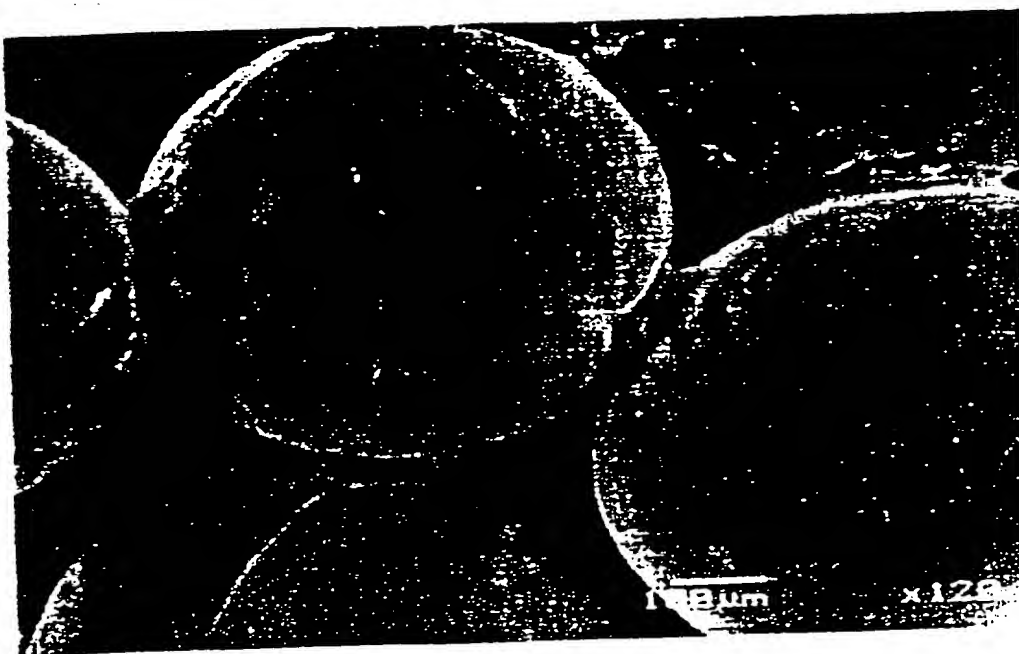
SEM micrographs of the Hayes CrCoMo sample after ASTM F746 corrosion test indicates intergranular corrosion attacks.

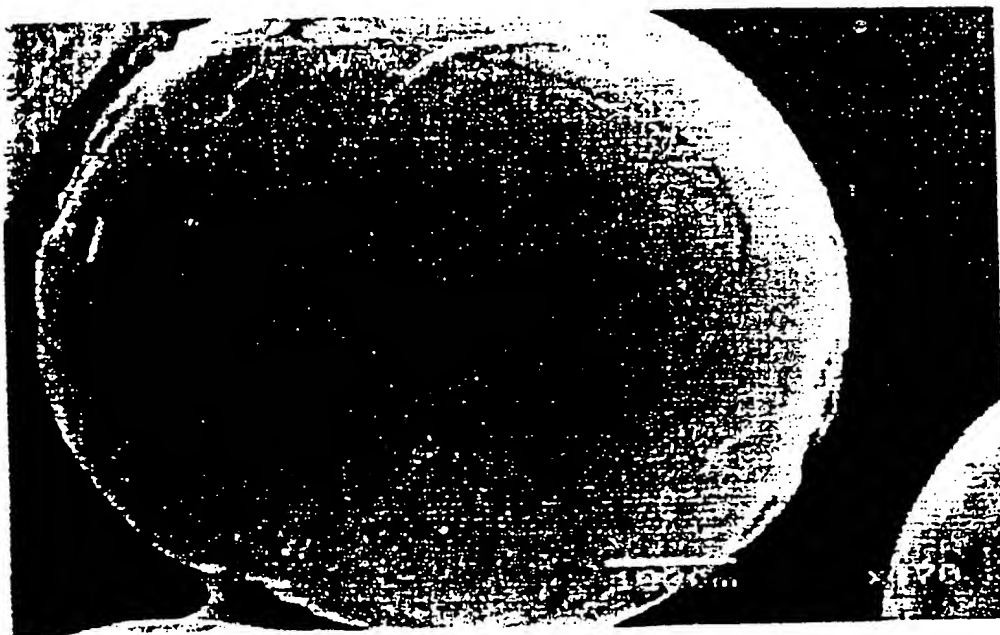
SEM micrographs of the Hayes CrCo sample prior to any corrosion test.
